CHAPTER 3 - EXISTING CONDITIONS

**CORRIDOR STUDY REPORT
US 550 FROM PASEO DEL VOLCAN TO NM 313**

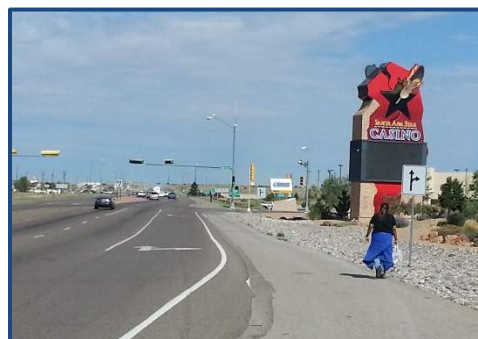
Currently, there is a mixture of 4, 5, and 6-foot sidewalks located on both the north and south side of the corridor from the Rio Grande Bridge to NM 313. There are no sidewalk facilities along US 550 from Paseo del Volcan to the Rio Grande Bridge, where, the corridor takes on a more rural characteristic incorporating a 10 to 14-foot wide shoulder on both sides of the road. During the field survey, there were several locations (five) along the corridor where street lights have been placed in the sidewalk thus significantly reducing the effective walking width.

Effective sidewalk widths were reduced anywhere from 2.5 to 3.5 feet, which is not ADA or PROWAG compliant.

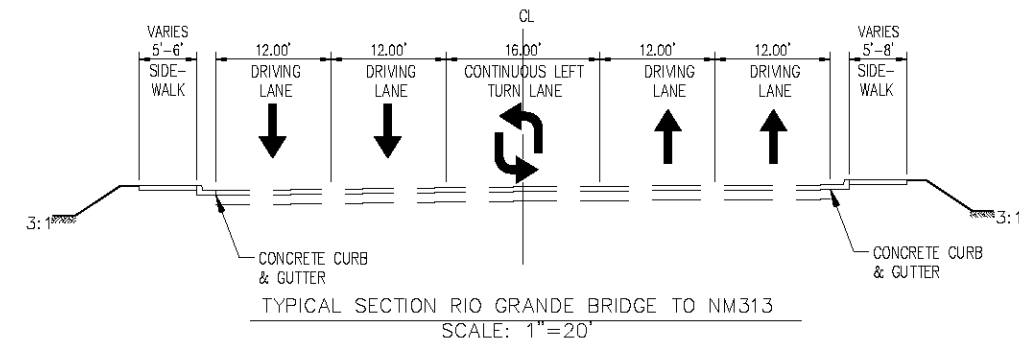
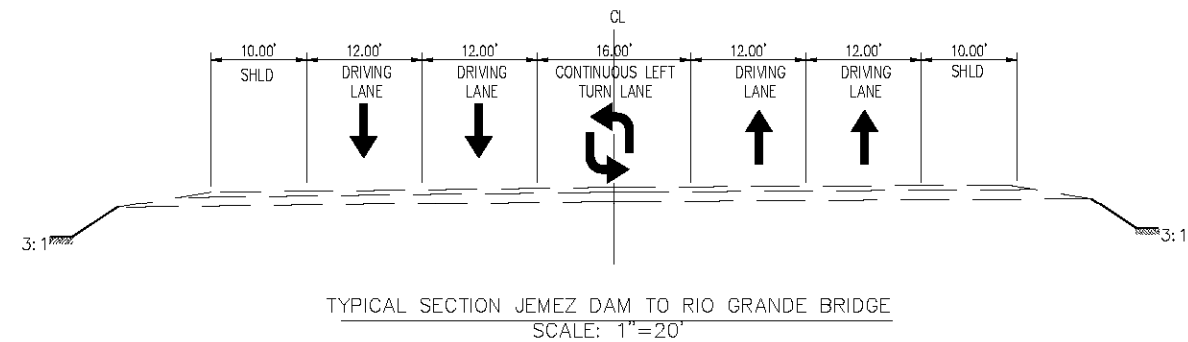
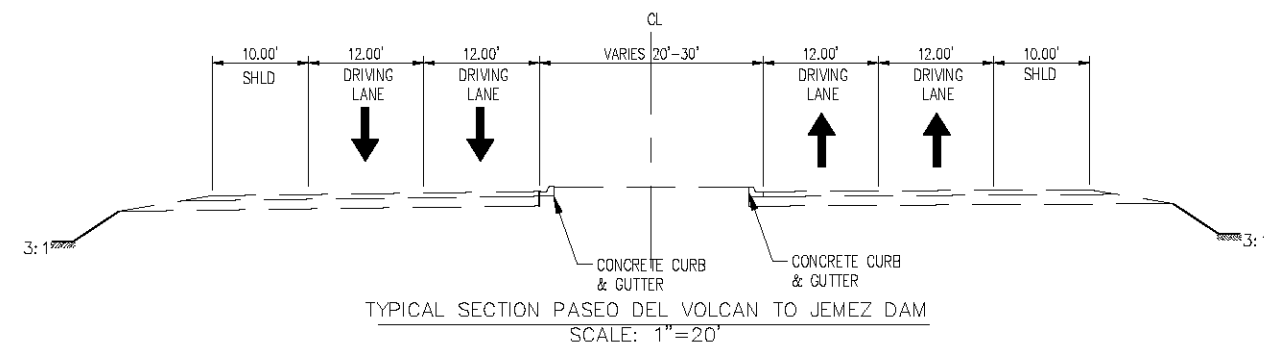
Figure 3.6 Existing US 550 Cross-Sections

The pavement section of US 550 is hot mix asphalt (HMA) pavement section which is generally in good condition. Between Paseo del Volcan and NM 528 the roadway is experiencing block cracking. The NM 528 intersection is beginning to rut. East of NM 528 there is patching and cracking. There is frequent minor longitudinal cracking and cracking at the pavement edge. The shoulders appear to have had pavement overlays and in some areas there are potholes and raveling.

Existing geometric conditions were evaluated using orthophotography and field observations. The horizontal and vertical alignments are adequate for the posted speeds.

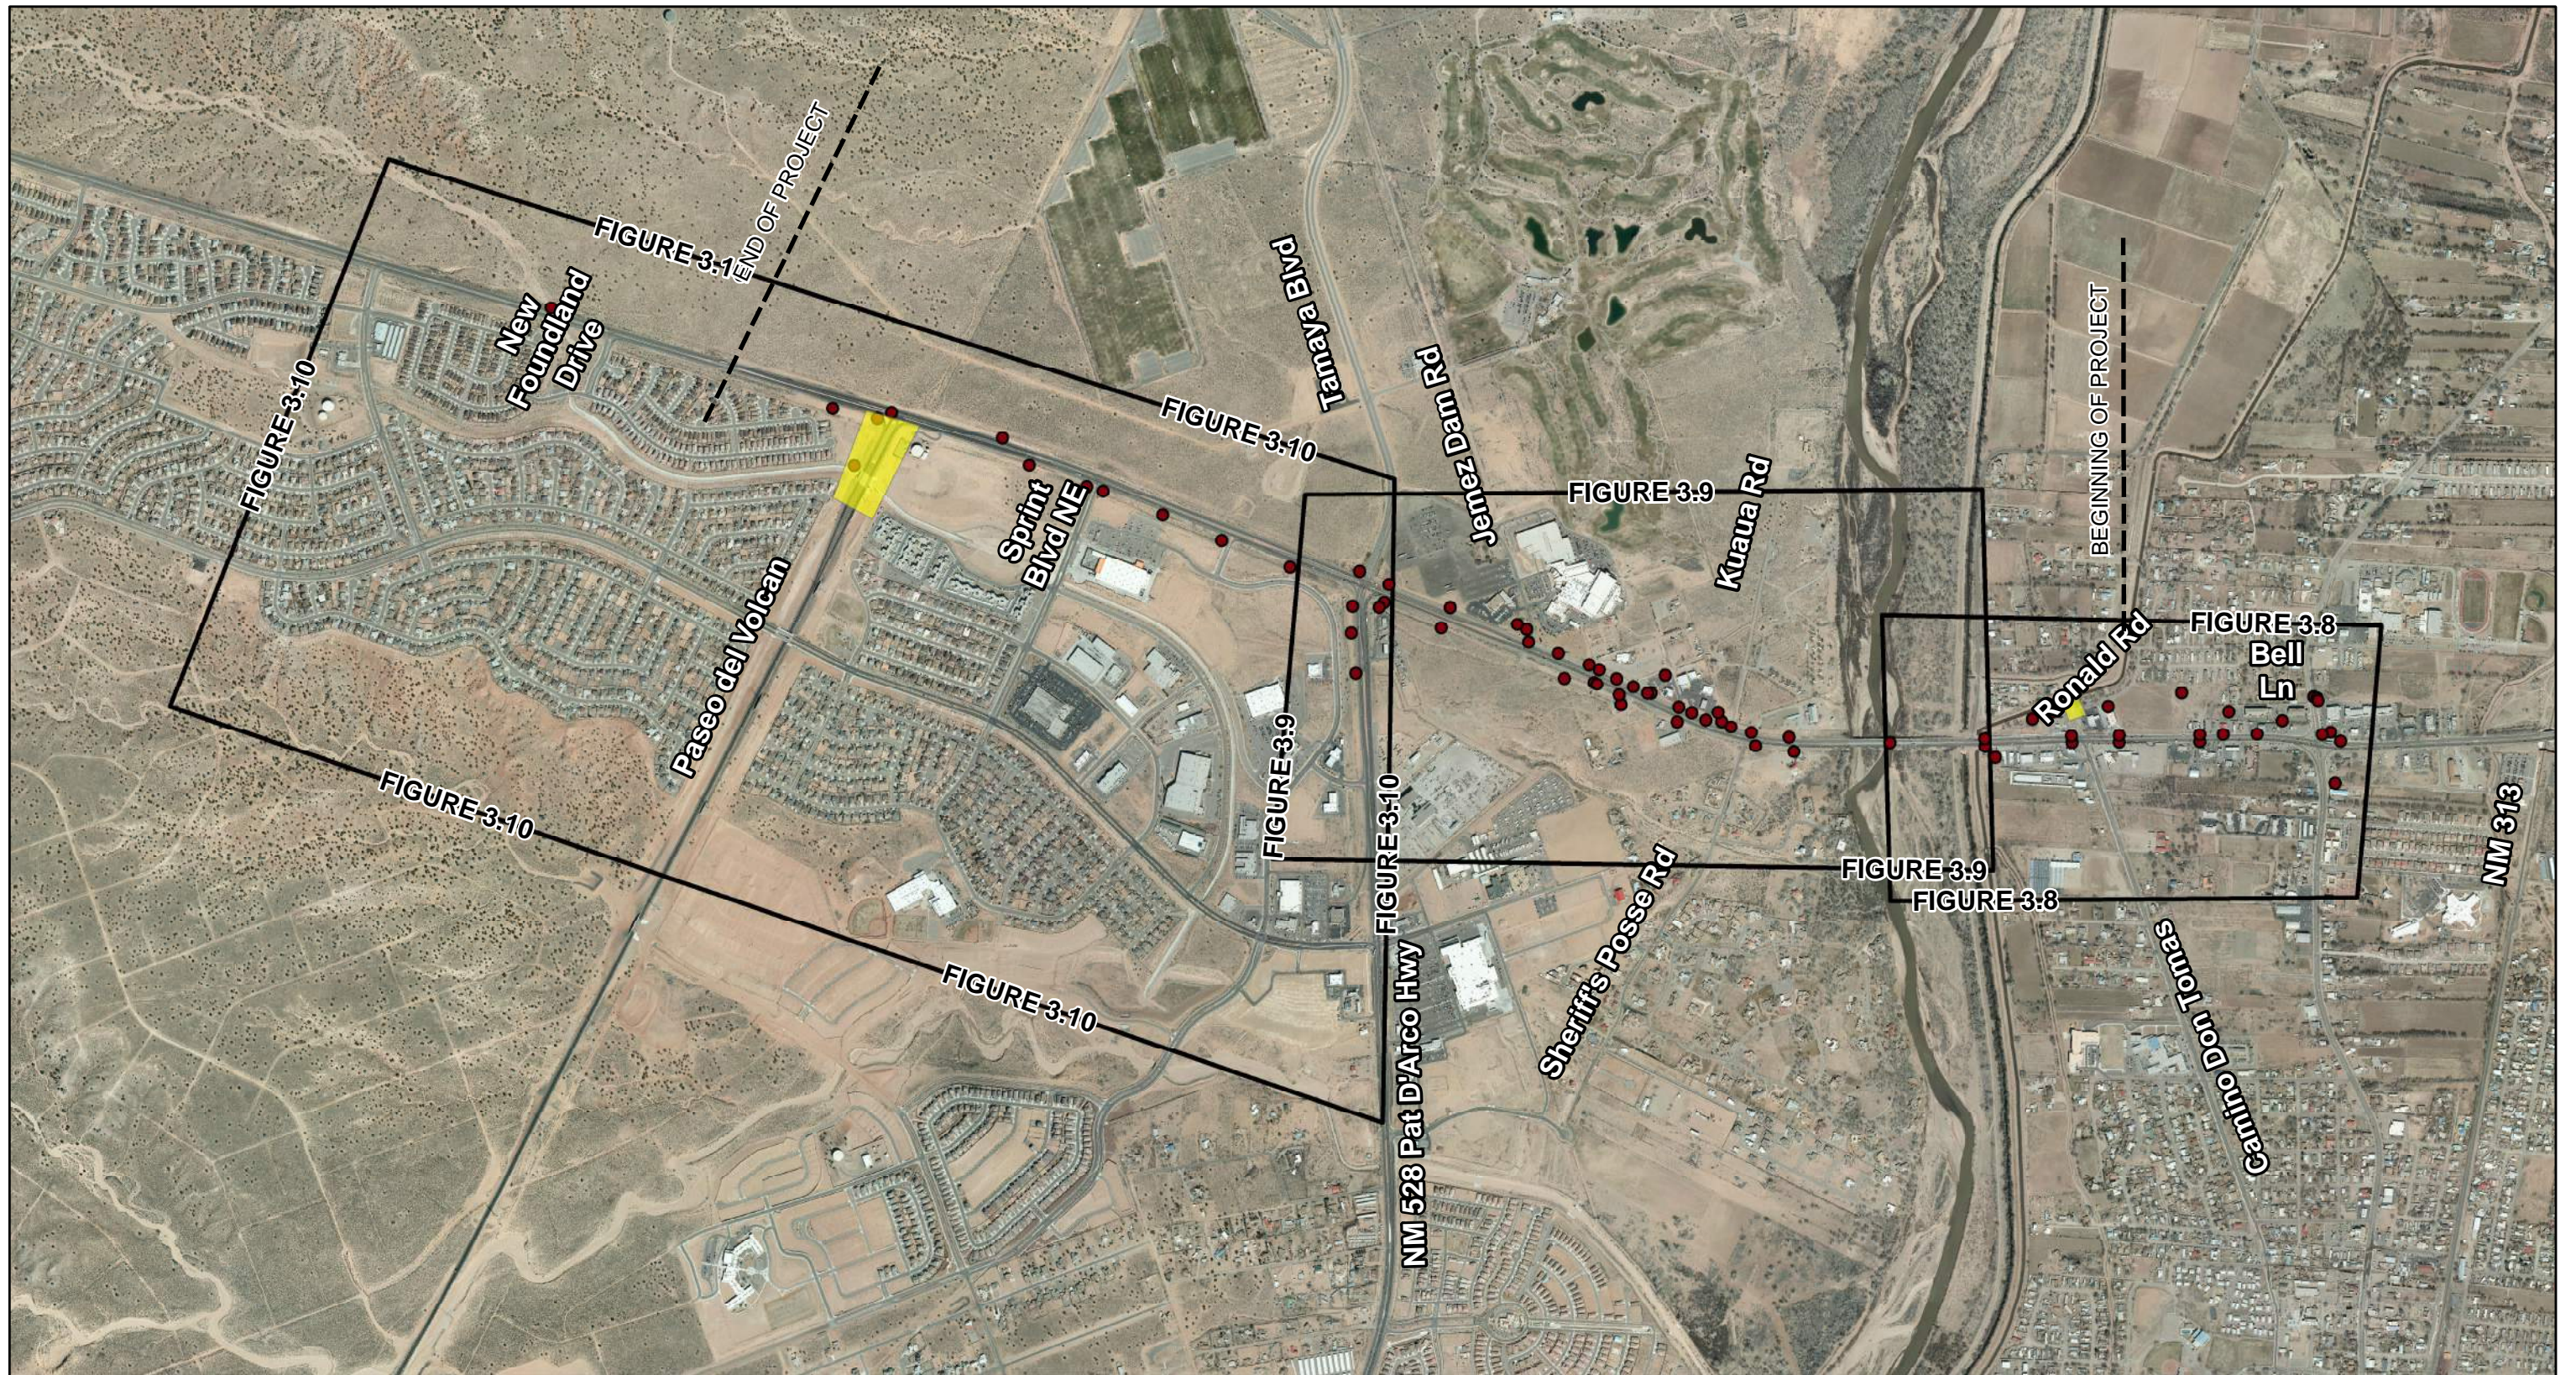
**FIGURE 3.7
EXISTING DRAINAGE STRUCTURES
KEY MAP**

Figure 3.7 shows the existing drainage flow patterns for the corridor area. From the beginning of project at NM 313, the general flow pattern is to the west, toward the river, though the gradient in this area is very flat. Runoff from east of NM 313 does not enter this study area; it is controlled through a series of inlets and retention ponds before reaching NM 313. US 550 roadway drainage in the area from NM 313 to the river is captured by inlets and a gravity storm drain system that outfalls to a pump station just east of the river and south of US 550. The pump station discharges to the Rio Grande. Adjacent businesses to US 550 in this area convey their runoff away from the roadway into individual retention ponds.

Two areas of concern for NMDOT were discussed. The first is at the end of project limits at Paseo del Volcan (PDV). PDV and this intersection are newly constructed and recent rainfalls caused closure of PDV south of the US 500 intersection due to large amounts of sediment and silt in the roadway and clogging inlets. Rill erosion is also an issue on the PDV embankments just south of US 550. PDV is owned by NMDOT and maintained by the City of Rio Rancho.
